FILTERS AND INTERNAL EROSION IN SWEDISH DAMS

SUSCEPTIBILITY OF INTERNAL EROSION IN THE SUORVA DAM

**Åke Nilsson,
SwedPower AB, Vattenfall Group,
Sweden**

Workshop on Internal Erosion and Piping of Dams and Foundations
25-27 April 2005 Aussois France

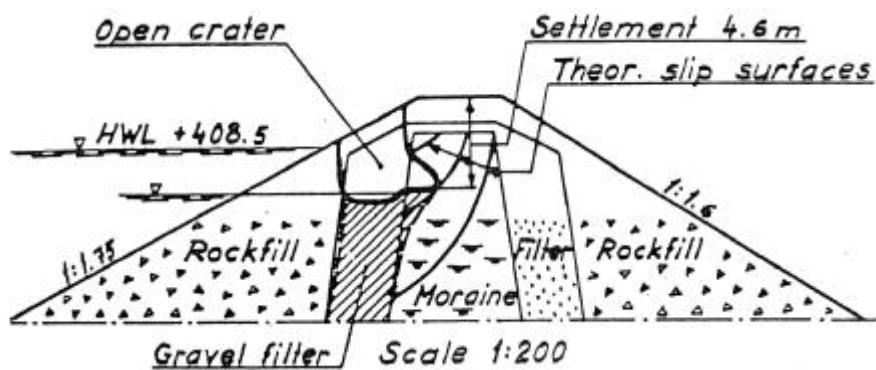
Bastusel Dam

Sinkholes occurred

1972
1973
1974
1983
1993

Downstream filter

$D_{\max} = 16 \text{ mm ?}$

$D_{15} = 1,6 \text{ mm}$

$D_{50} = 5,3 \text{ mm}$

Impervious core

Content of fines = 60%

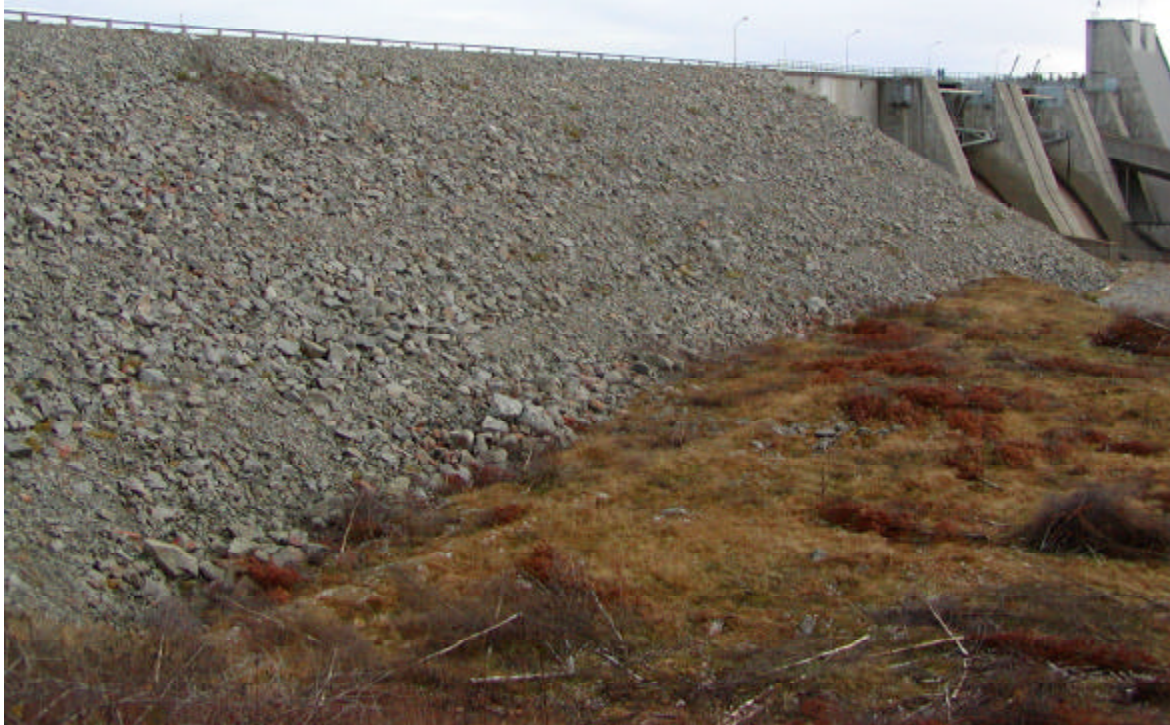
Hällby Dam constructed in 1970 has experienced several sinkholes during the years and the core was grouted in 1983.

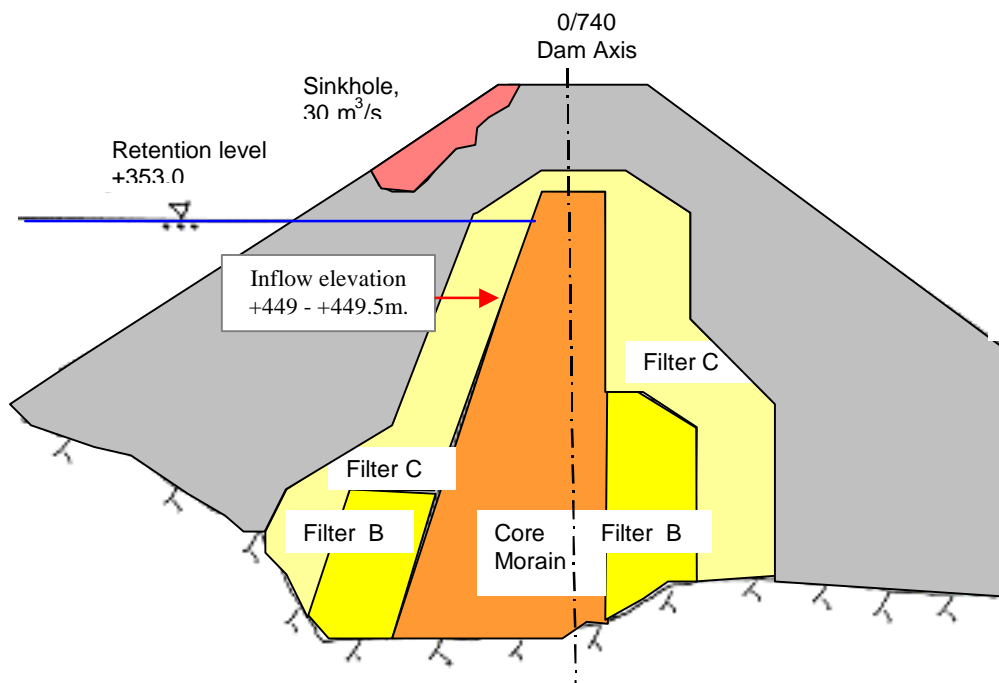
Section at the sinkhole which occurred in 1983

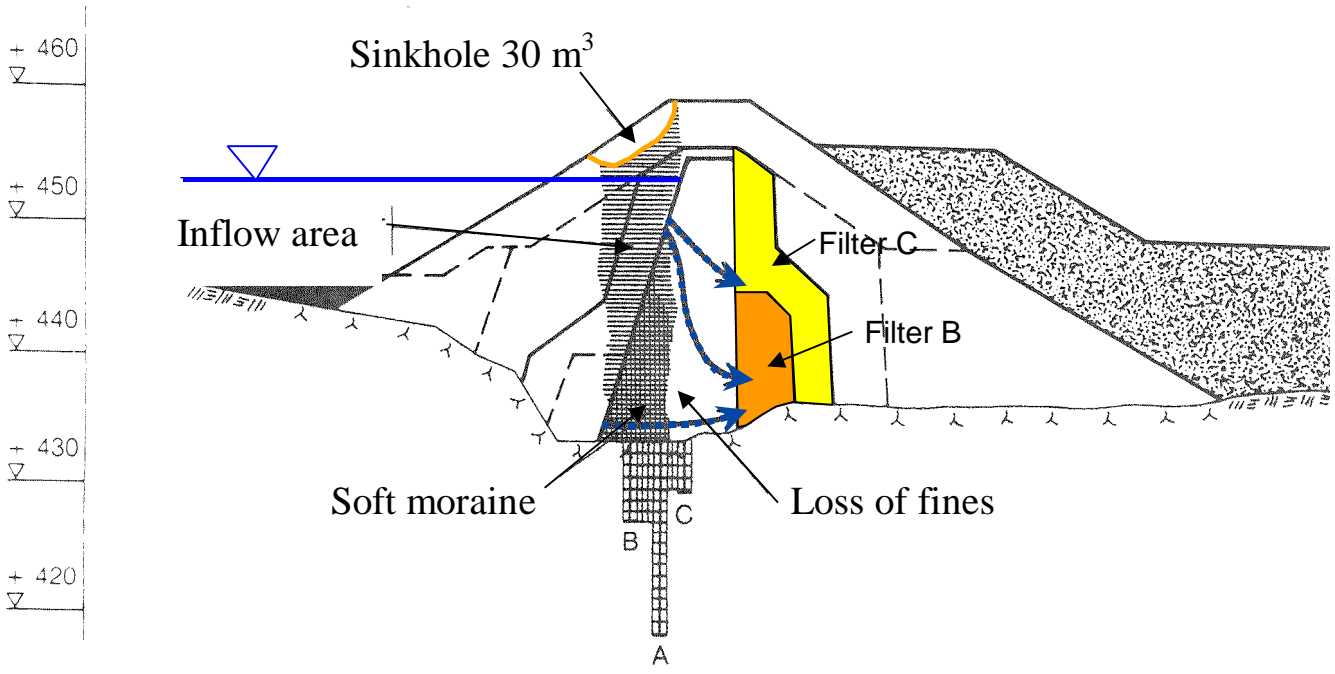
Possible leakage path during the incident in 1983

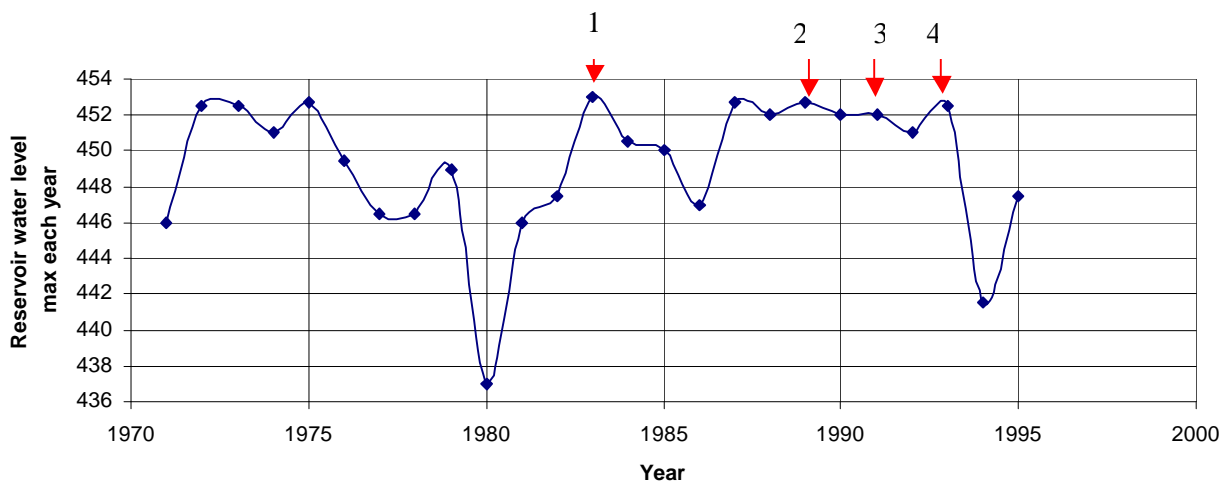
Reservoir level

1. 1983-10-04 sinkhole app. 30 m³ in the East Dam (0/740)
2. 1989-08-14 sinkhole 4 to 7 m³ in the East Dam in chainage 0/650
3. October 1991 turbid water and increased leakage in measuring weir M1 in the East Dam
4. August 1993 "small depression in the East Dam

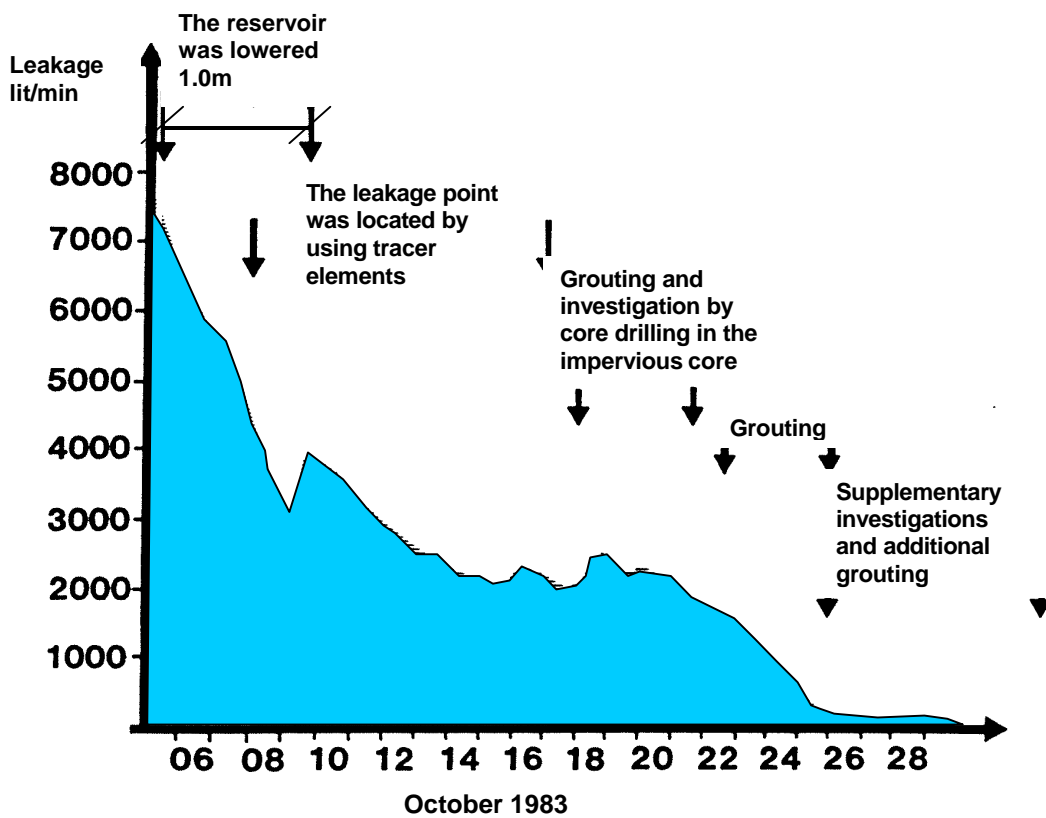
Leakage during the Suorva incident in 1983

All the leakages self-healed. In one of the incidents grouting and lowering of the reservoir was also used.

Self-healing process was likely caused by collapse of the erosion pipe.

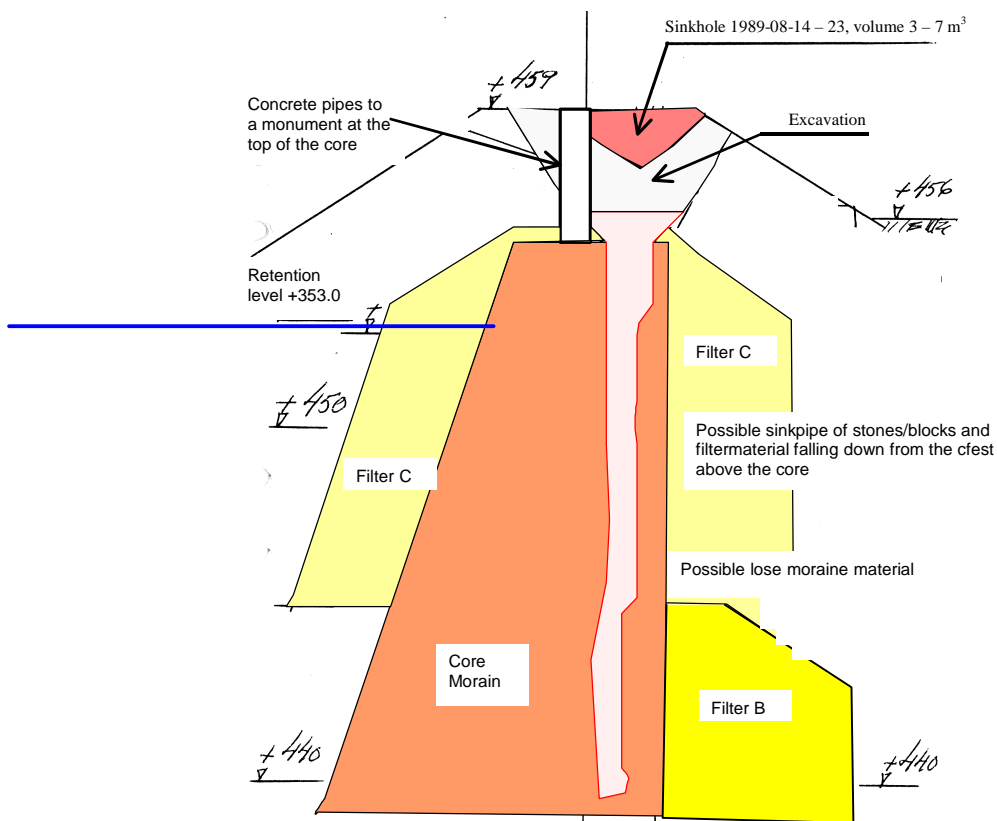
Sinkhole that occurred in 1989

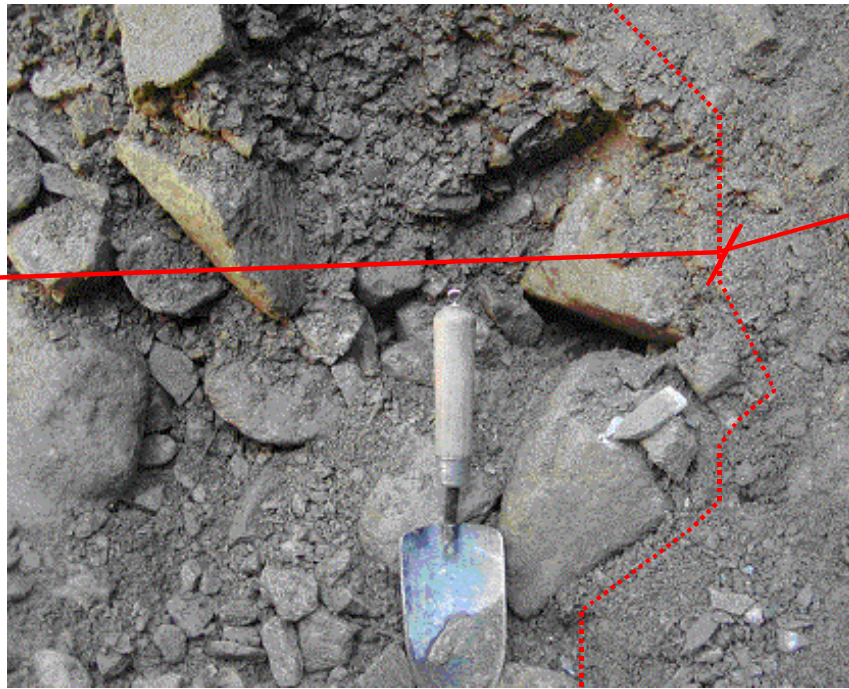
**Downstream filter in the upper part of the dam
(to the left in the photo) and
moraine in the core (to the right in the photo).**

Filter
downstream
the core

Downstream filter is coarse with a D15 of approximately 4 mm as a maximum and 2 mm as an average.

In at least one of the incidents the leakage started at the foundation level. The main reason for the internal erosion to continue and create sinkholes is judged to be the coarse filter.

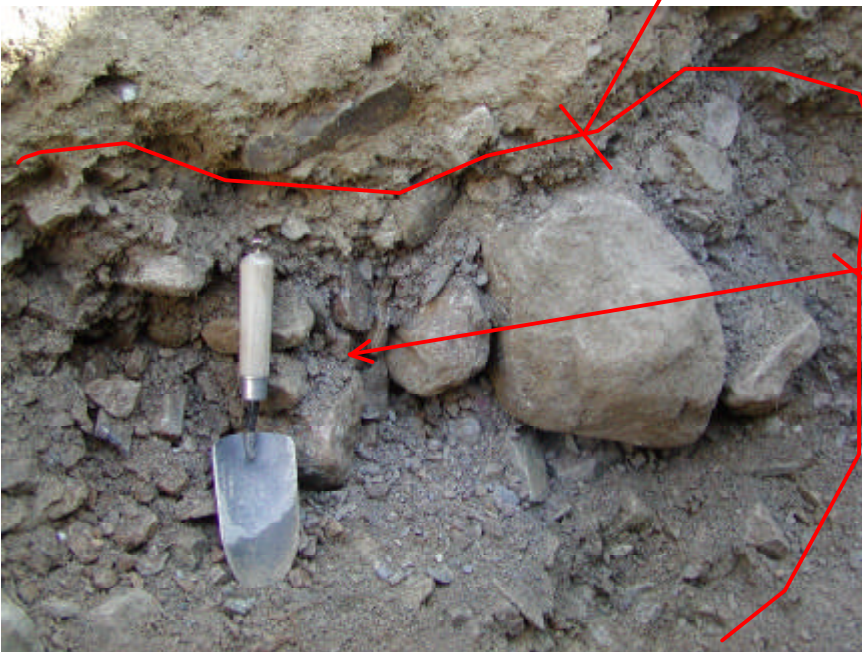
Moraine in
the core

The content of fines in the moraine in the impervious core is high (usually >40%).
