FILTERS AND INTERNAL EROSION IN SWEDISH DAMS

SUSCEPTIBILITY OF INTERNAL EROSION IN THE SUORVA DAM

**Åke Nilsson,
SwedPower AB, Vattenfall Group,
Sweden**

Workshop on Internal Erosion and Piping of Dams and Foundations
25-27 April 2005 Aussois France

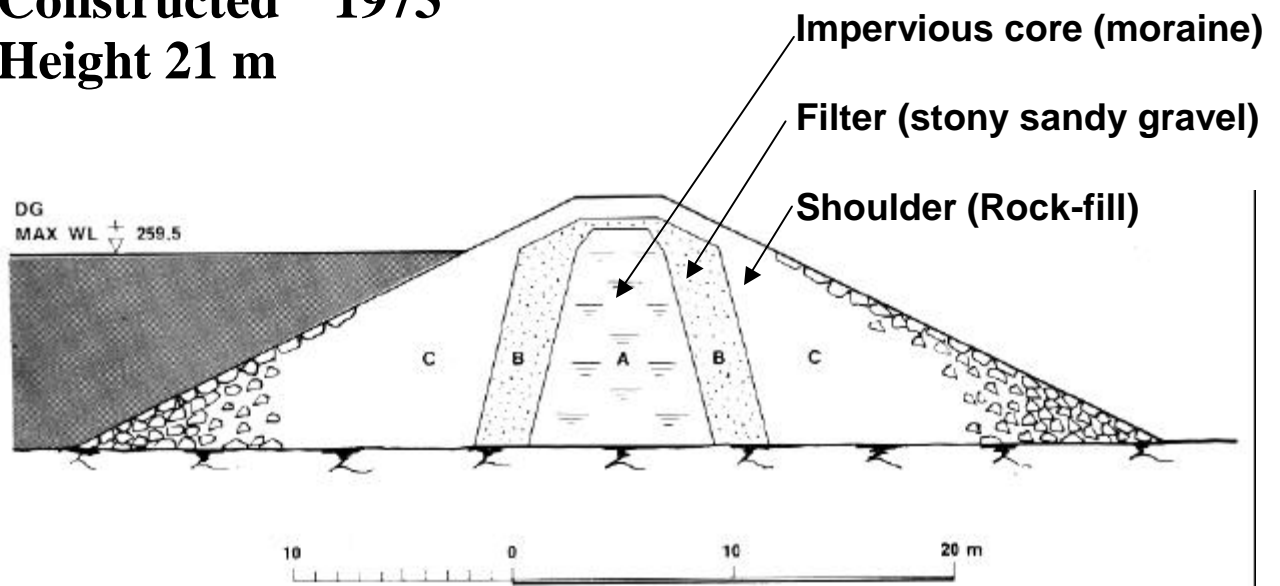
Bastusel Dam

Sinkholes occurred

1972
1973
1974
1983
1993

Downstream filter

$D_{\max} = 16 \text{ mm ?}$

$D_{15} = 1,6 \text{ mm}$

$D_{50} = 5,3 \text{ mm}$

Impervious core

Content of fines = 60%

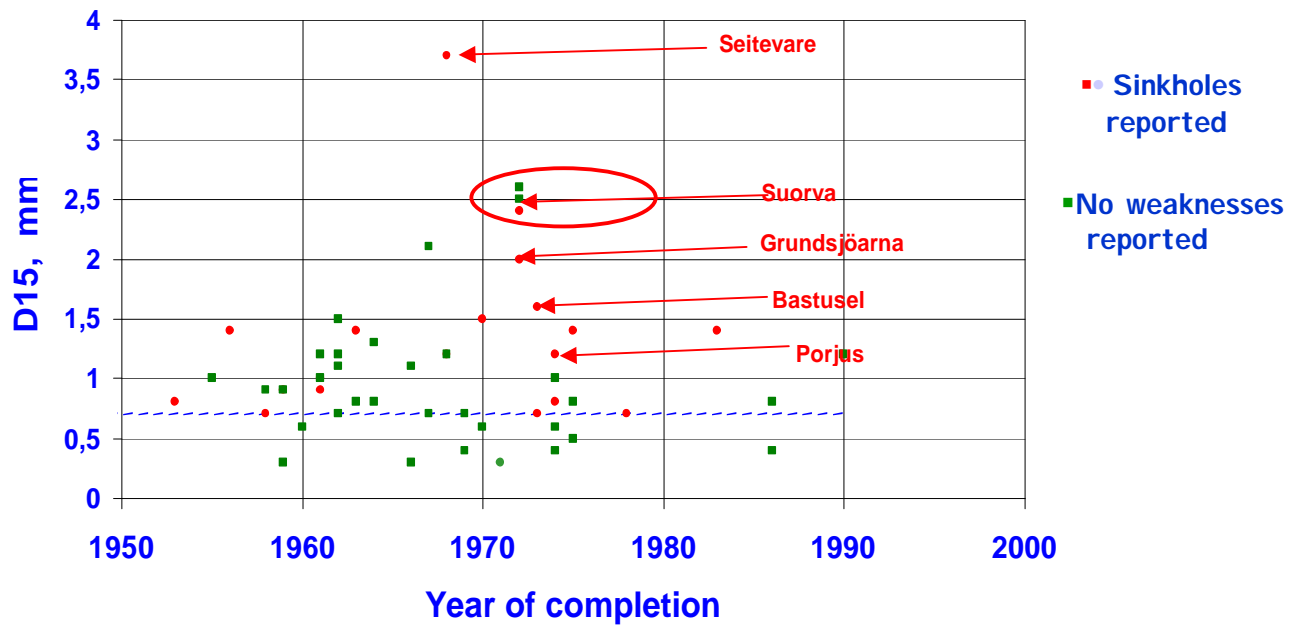
D15 for the filter vs year of completion of the dam

D15 for downstream filter

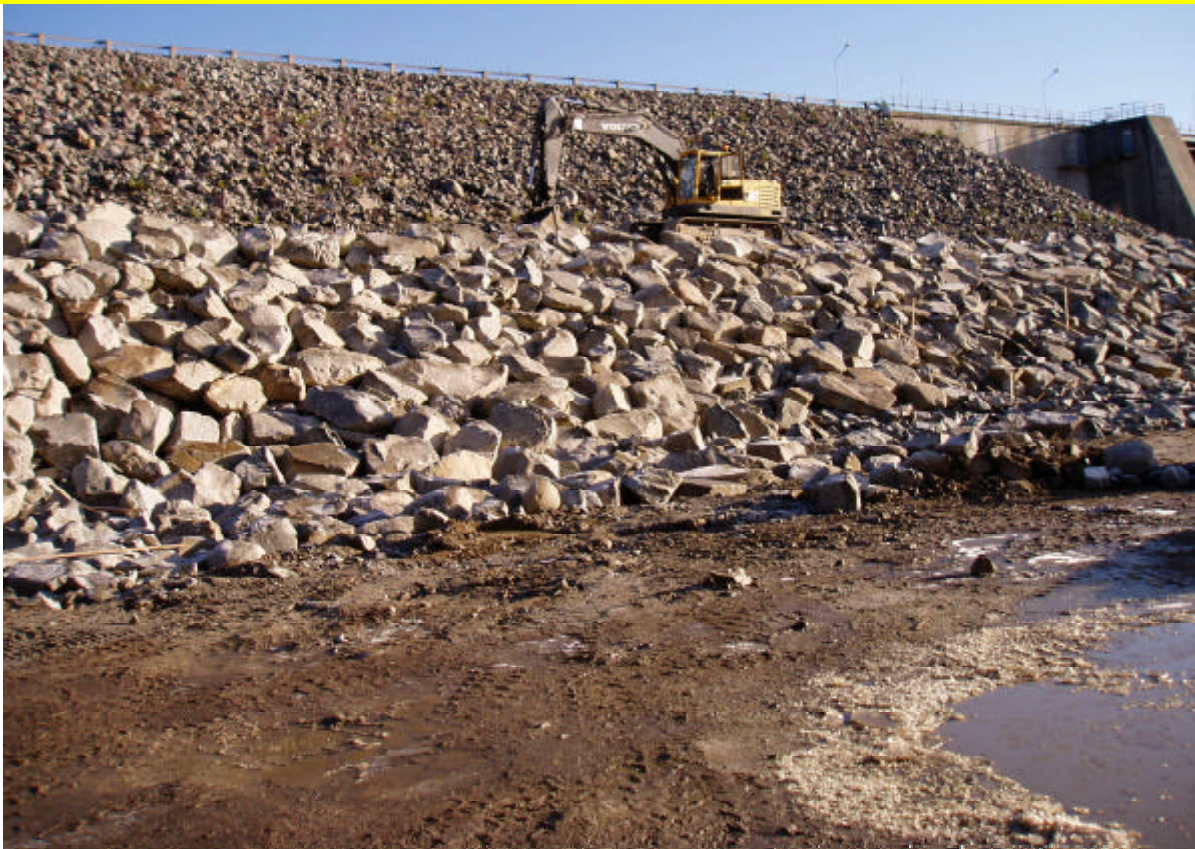
Hällby Dam was in 2004/05 strengthened by a rockfill berm in order to allow for possible large leakages in the future.

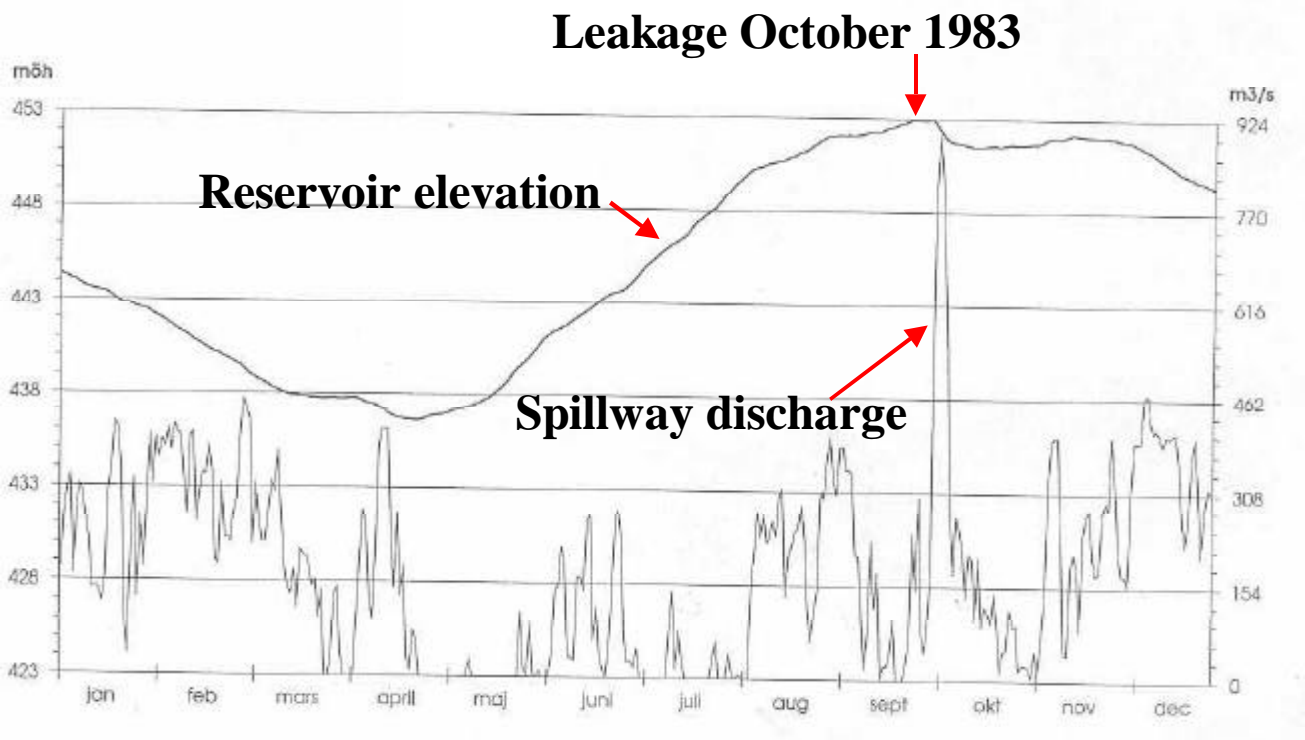
1. 1983-10-04 sinkhole app. 30 m³ in the East Dam (0/740)
2. 1989-08-14 sinkhole 4 to 7 m³ in the East Dam in chainage 0/650
3. October 1991 turbid water and increased leakage in measuring weir M1 in the East Dam
4. August 1993 "small depression in the East Dam

Reservoir level

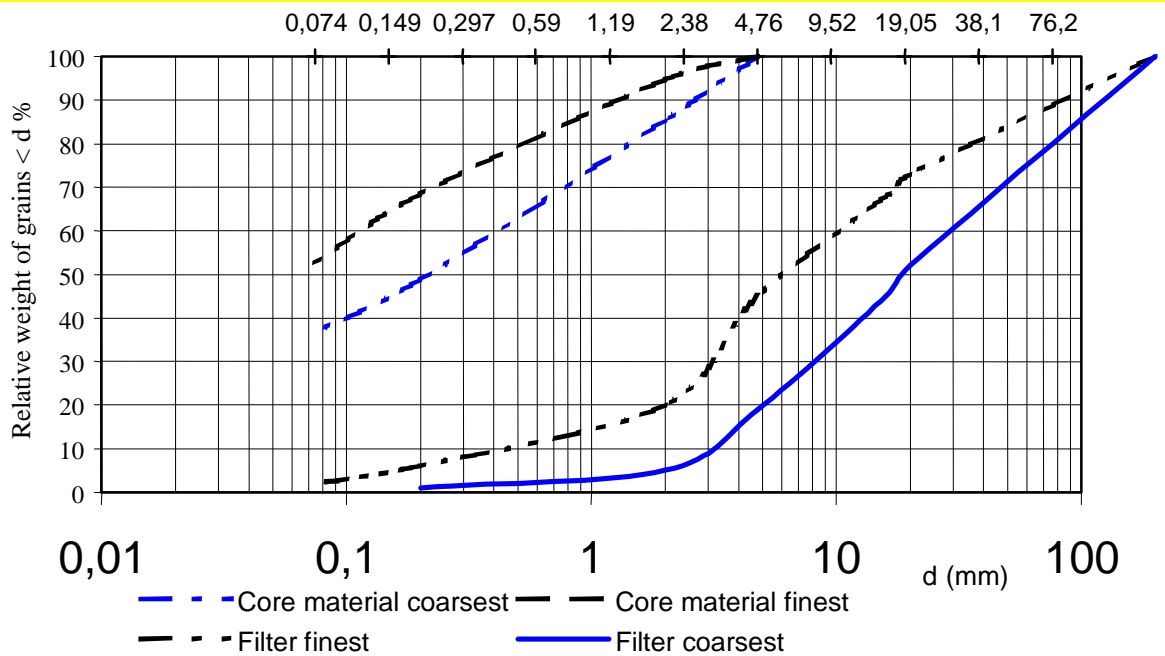
Grain size distributions for downstream filter in the upper part of the dam and moraine in the core

The content of fines in the moraine in the impervious core is high (usually >40%).

Downstream filter is coarse with a D15 of approximately 4 mm as a maximum and 2 mm as an average.

In at least one of the incidents the leakage started at the foundation level. The main reason for the internal erosion to continue and create sinkholes is judged to be the coarse filter.

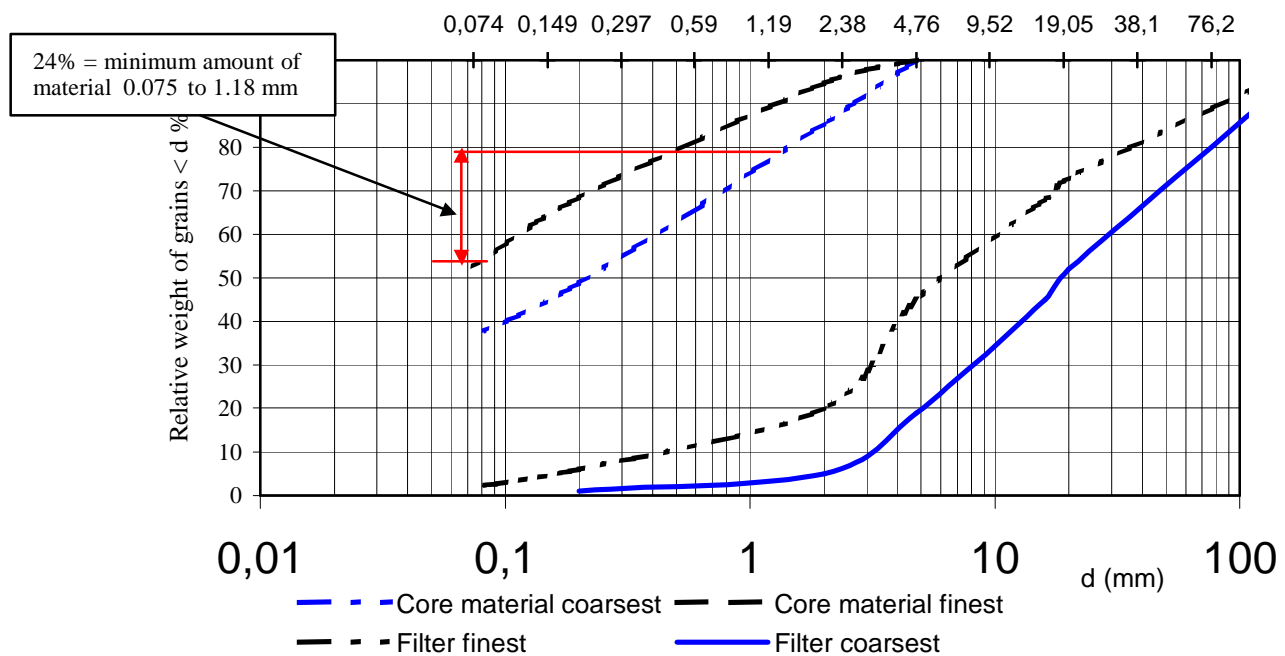
Grain size distributions for downstream filter in the upper part of the dam and moraine in the core (Foster and Fell 2001)

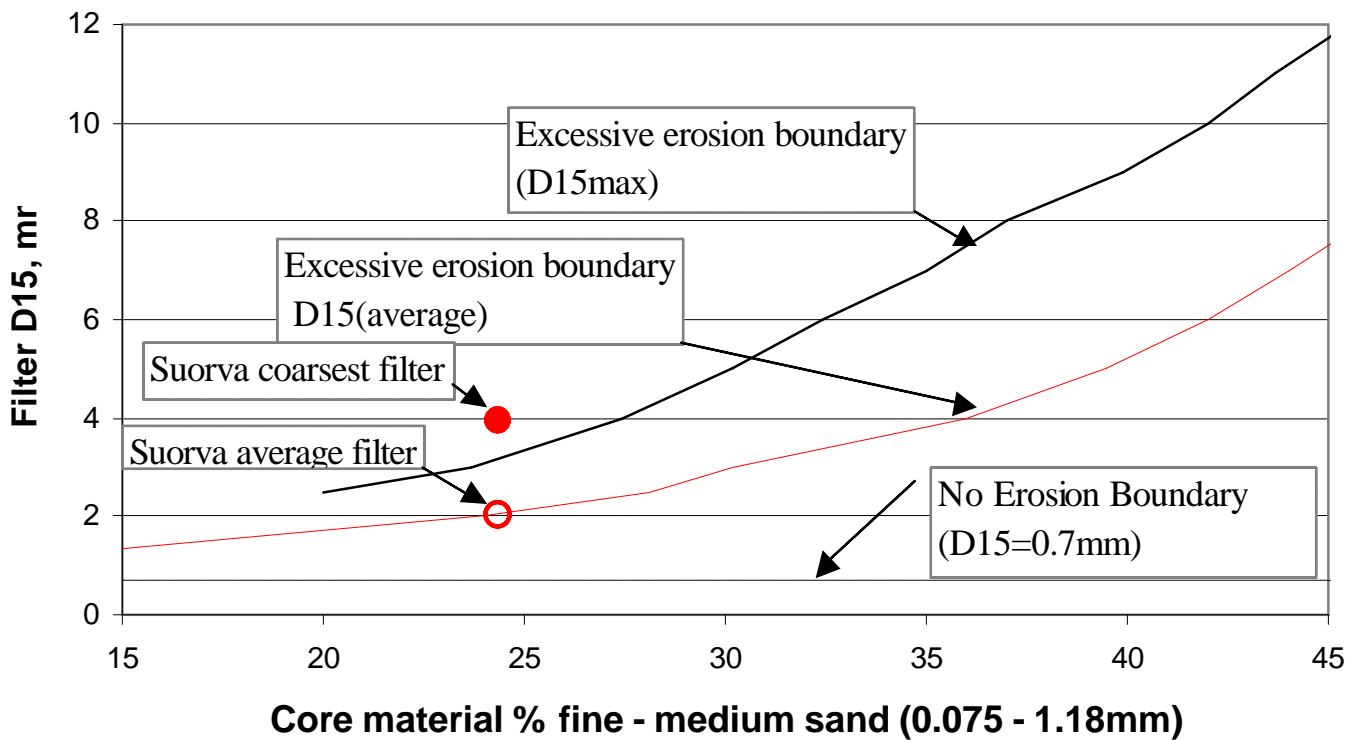
Erosion losses of base soils measured in filter tests (Foster and Fell 2001)
